EXTENSIVE PILE TESTING OF AUGER PRESSURE GROUTED DISPLACEMENT (APGD) PILES, LOS ANGELES, CALIFORNIA

Michael D. Reader, RCE, GE, Principal Engineer, Group Delta Consultants, Inc., Torrance, CA
Todd W. Armstrong, RCE, Project Engineer, Group Delta Consultants, Inc., Torrance, CA

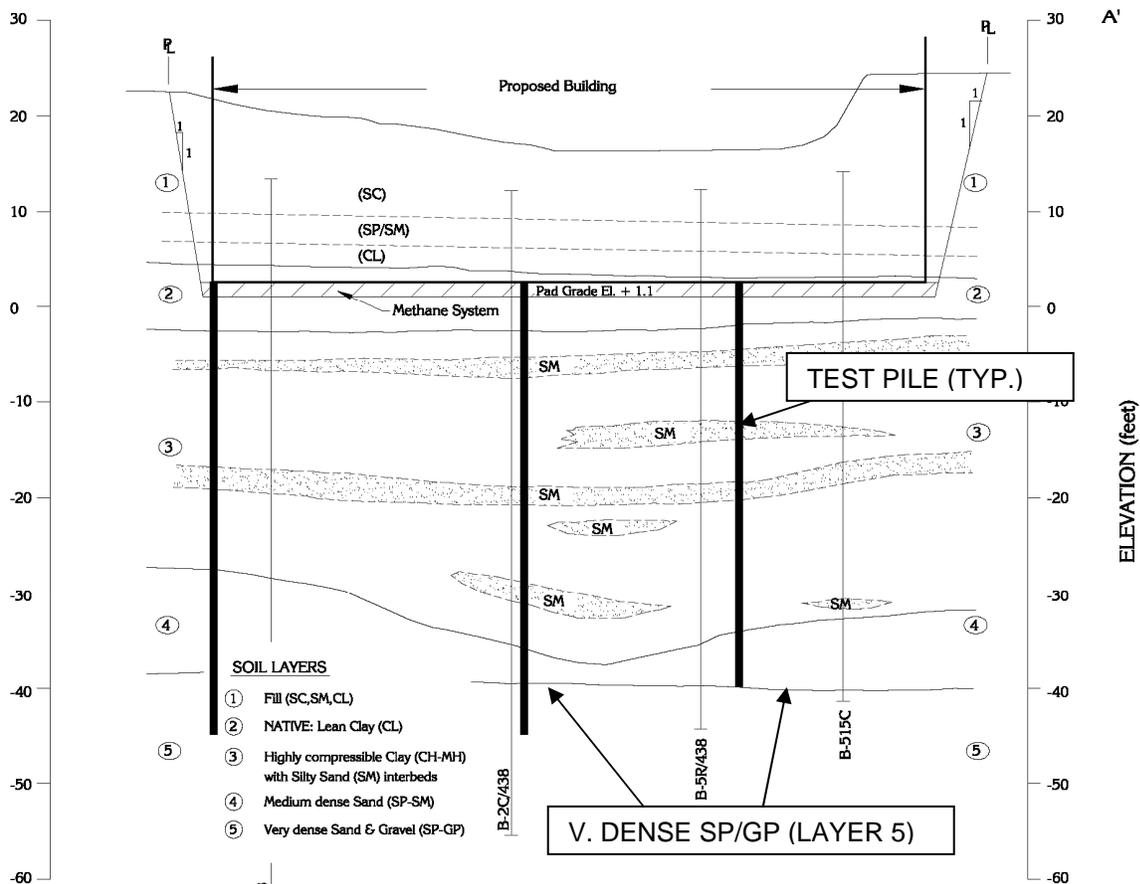
Figure 2. Typical geotechnical cross section for Test Areas A and B. contents are between 34 and 79 percent for the

The test areas were located within excavations into compacted fill at the sites of two future buildings. The working surfaces for Test Areas A and B were at roughly El. +7 feet and El. +1.4 feet, respectively. Exploration borings encountered fill materials (referred to as Layer 1) extending from the working surface to depths generally ranging from about 2 to 5 feet. The fill at Test Area A was comprised of silty to clayey sand and sandy clay fill, while Test Area B was topped with 2 feet of poorly graded gravel fill. The native alluvial soils found below the compacted fill consisted of alternating layers of clays, silts and sands of variable density/consistency. A generalized geotechnical cross section representative of the two sites is shown in Figure 2. The cross-section shows the proposed building location, pre-excavation grade and load-testing grade. Groundwater levels were measured at approximately 3 feet and 1 foot below the working surfaces of Test Areas A and B, respectively. Each of the alluvial soil layers is discussed in the following sections.

Layer 2 is comprised of firm to stiff, fat to lean clays and low plastic silts, extending from below the fill to about El. -3 feet. The natural moisture content ranges from 36 to 48 percent for the clay. The liquid limits ranging between 43 and 58 and plastic limits between 22 and 32. The CPT tip resistance ranges between 7 and 57 tsf. The undrained shear strength ranged 0.25 to 2.5 tsf.

Layer 3 extends from El. -3 to El. -38 feet. These soils consist of soft to firm, high plasticity clays and silts having liquid limits ranging between 51 and 85 and plastic limits between 22 and 43. Several interbeds of silty sand, 1 to 3 feet thick, were identified within Layer 3. The natural moisture

Layer 4 is comprised of medium dense sand and silty sand ranging from El. -38 to El. -41 feet. The cone tip resistance in this layer ranges from 40 to 190 tsf. The SPT blow counts recorded in this layer ranged 11 to 54 and this layer comprises approximately 10% fines.

Layer 5 is comprised of very dense sands and gravels with some cobbles, extending below El. -41 feet. The SPT blow counts in this layer are generally greater than 50. The cone tip resistance in this layer generally ranges well above 250 tsf. Cone penetration testing in this layer is made difficult due to a concentration of gravel and cobbles often found at the top of this layer, resulting in a cone tip resistance often exceeding 700 to 1000 tsf. CPT refusal often occurred in such conditions, but those soundings that managed to penetrate this “armored” upper surface of Layer 5 indicated cone tip resistance dropping to 250 to 400 tsf.

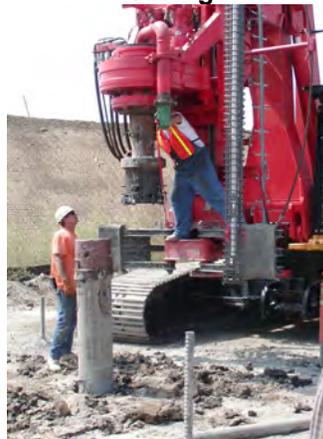
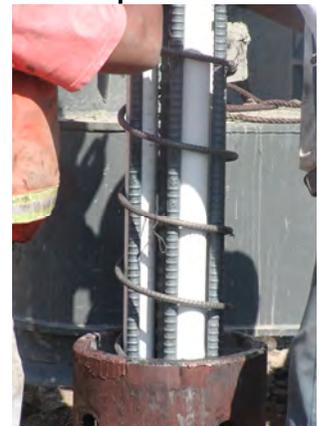
Drill head detached from Casing

Inserting Rebar Cage with Inspection Tubes

Figure 3. Installation of APGD pile by Dry Dip Method.

Four piles were installed in this area from about Elevation +7.0 feet. The pile tips extended to a depth of about 50 feet, which penetrated 1 foot into the dense sand and gravel layer that underlies the site at an Elevation of about -42.0 feet. During the first stage of installation the displacement auger was drilled into the ground to the desired depth. The drilling process produces minimal cuttings at the surface because the reverse flight augers above the displacing element push the soil cuttings laterally into the wall of the shaft. The resulting shaft was smooth-walled and about 16 inches in diameter (equivalent to the outside diameter of the displacing element). Figure 3 illustrates APGD pile installation by Dry Dip method.

The second stage of pile installation involved placing reinforcing steel. After the target elevation was reached, the top of the displacement auger was opened and the reinforcing steel was inserted inside with access tubes attached for non-destructive testing. Two piles in this area were designed for axial tension testing and the other two for axial compression, so different configurations of reinforcing steel and access tubes were necessary. Spacers kept the reinforcement positioned within the shaft.

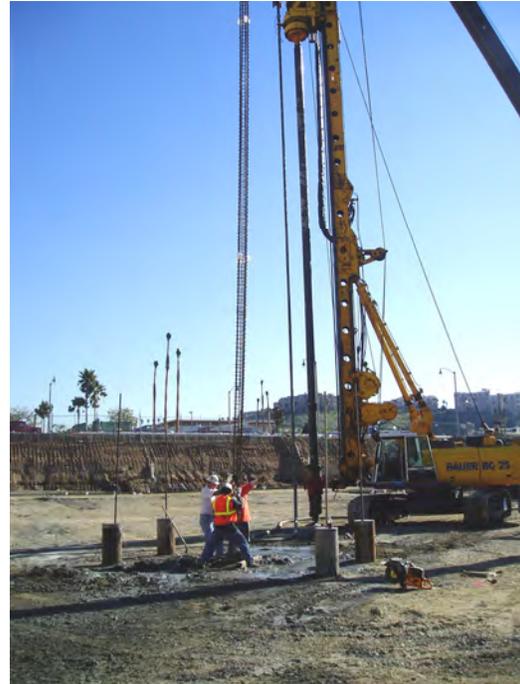
Figure 4. Installation of APGD pile by Wet Dip Method. Note “Wet Dipping” of rebar cage into grouted pile.

Five test piles were installed at the site from about Elevation +1.4 feet and extended to roughly 45 to 49 feet below grade. Penetration into the dense sand and gravel layer that underlies the site (about El. – 40 feet) ranged from 4.2 feet to 10.0 feet. The displacement auger was drilled into the ground to the desired depth in a manner similar to Test Area A. The main difference between this method and the dry method is that grout was pumped before the reinforcing steel was placed into the shaft. The displacing element pushed the soil cuttings laterally resulting in a shaft about 16 inches in diameter (equivalent to the diameter of the displacing element). Grout was also pumped into the shaft in a similar manner, through the grout port of the displacement auger once the ultimate penetration depth was achieved. Figure 4 illustrates APGD pile installation by Wet Dip method.

In the third stage of installation, the reinforcing steel and GDL access tubes were lowered into the fluid grout column. The access tubes were coupled with full-length longitudinal bars. The reinforcing cage was then lowered over the GDL access tube assembly. All reinforcing elements were fitted with

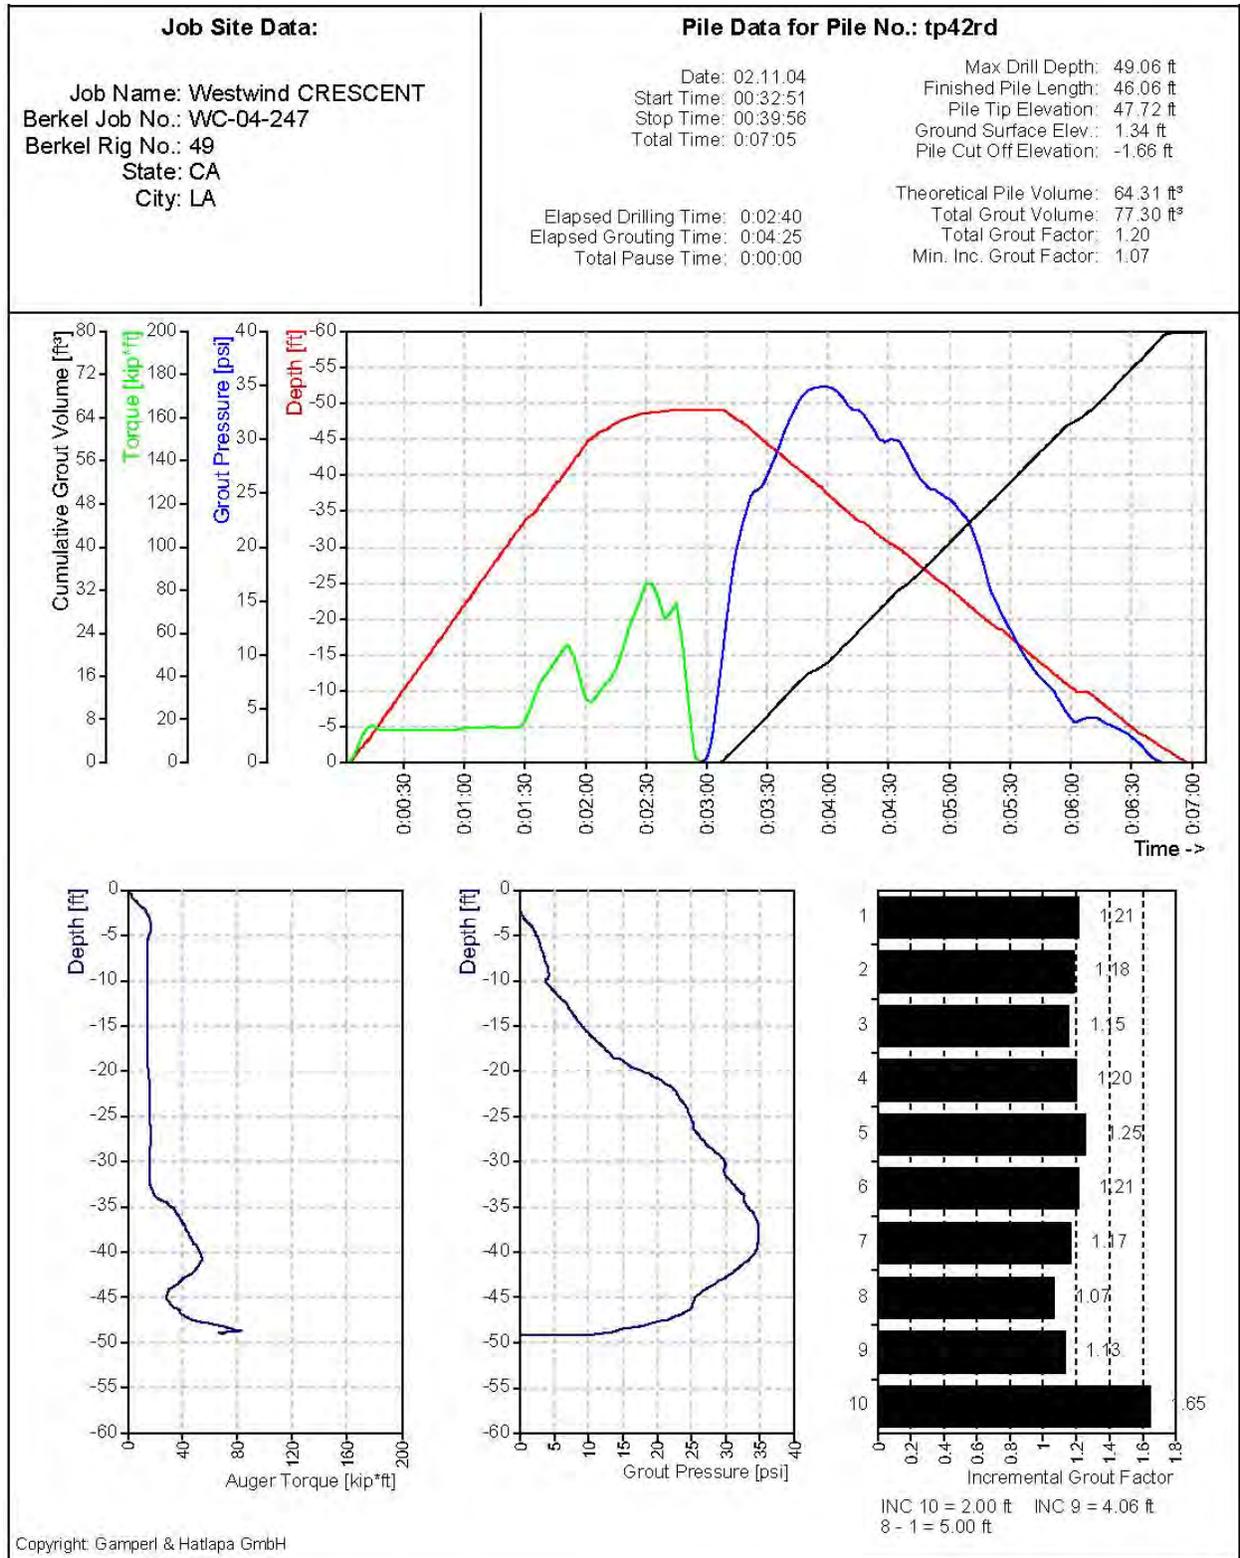
Figure 5. Example of an output chart from an automated monitoring device.

installation information were presented in a chart format of the installation record, plotted as a single-page record for each pile. This information would also be used later to correlate with piles that were exhumed. Figure 5 provides an example of an output plot of installation data for Pile 42 located in Test Area B.

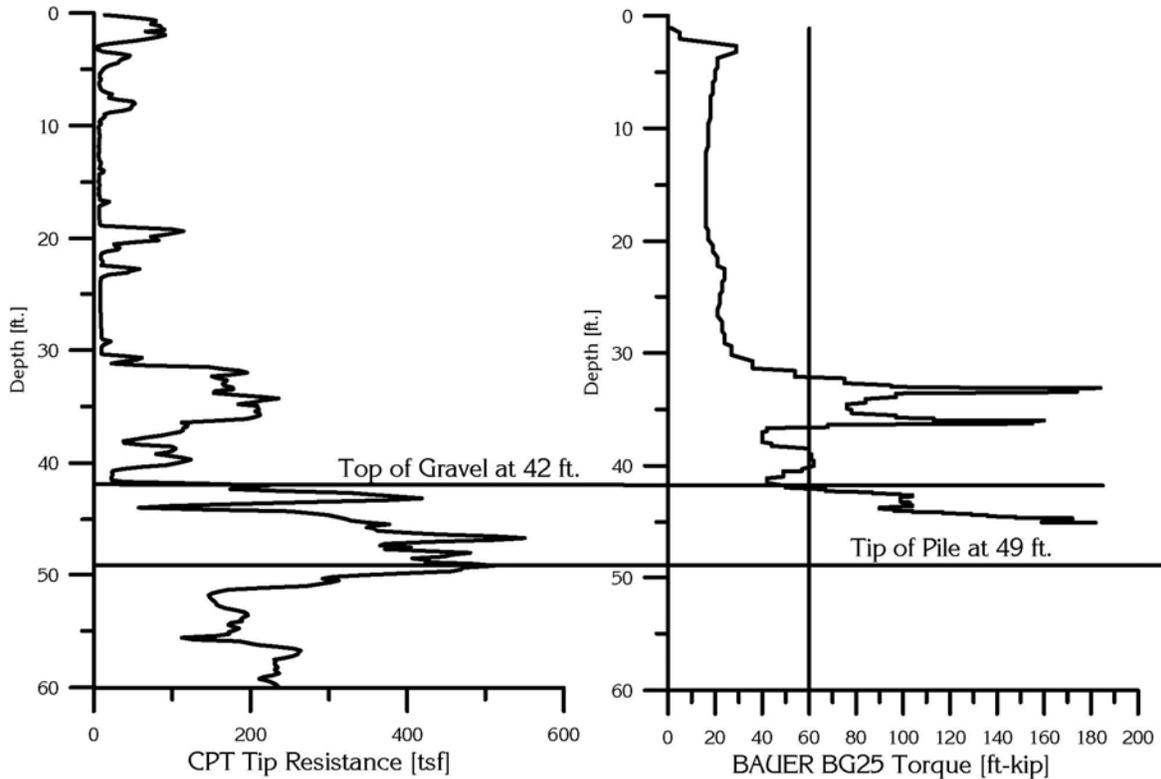
Figure 6. Correlation of CPT tip resistance with drill torque developed during pile installation.

The record of drill torque versus depth was also used as an installation criterion in order to ensure that production piles achieved a minimum penetration into the dense gravelly sand bearing layer. CPT soundings at each test pile location indicated the depth to the bearing layer. From comparison to the CPT logs, it was generally found that a drilling torque of 60 ft-kip confirmed the bearing layer of very gravelly sand was reached during drilling. Figure 6 illustrates the correlation between CPT tip resistance and drill torque for Pile 42 located in Test Area B. It is interesting to note that the 60 ft-kip indicator of dense gravelly sand was generally independent of tip configuration, auger configuration, drilling contractor, or drilling equipment.

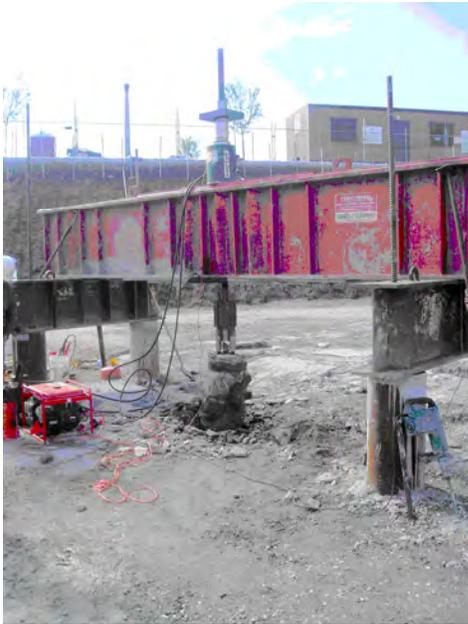
Figure 7. Load testing frame for testing under axial tension.

The primary goal of the load-testing program was to establish a design capacity of the piles, which considered how potential liquefaction affects down-drag under seismic conditions. In Test Area A, the four test piles were divided into two axial compression tests and two axial tension tests. The five test piles in Test Area B involved axial compression testing only. Figure 7 shows a typical axial load testing apparatus setup.

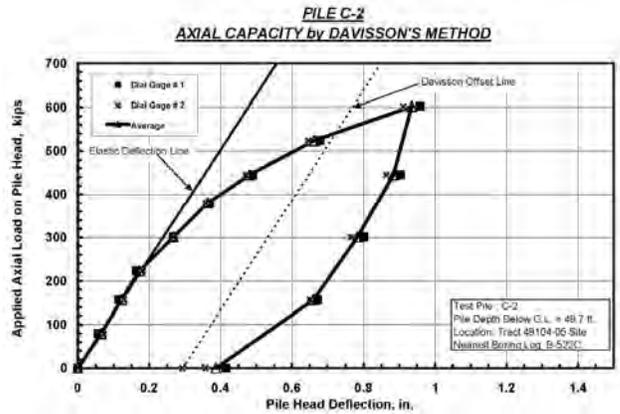
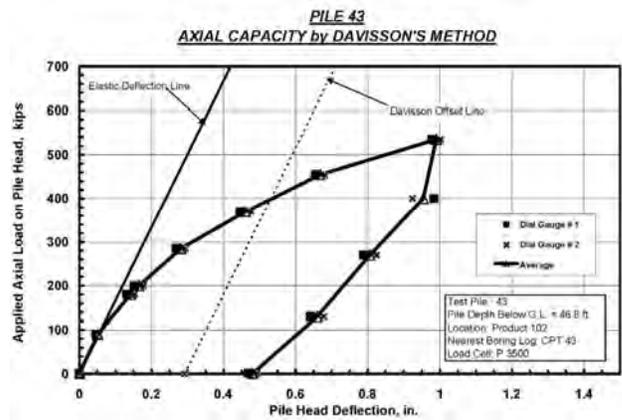
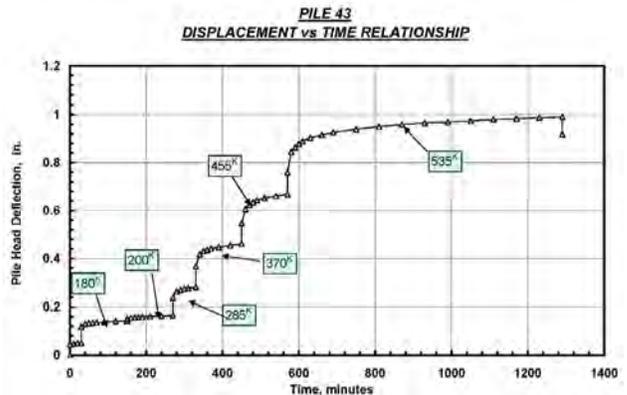
Figure 8. Typical load-displacement curves for axial compressive testing: (a) Test Area A; (b) Test Area B; (c) displacement versus time relationship.

piles installed. This method seemed to predict pile capacity equivalent to the load developed at 0.5 to 0.75 inch of pile head displacement. For an ultimate load at 360 kip, two times the allowable, the largest pile head deflection was measured at 0.66 inch. In fact, most of the 9 test piles showed less than 0.5 inch deflection at 360 kip, which was deemed acceptable. Figure 8 shows typical load displacement curves from testing results in Test Areas A and B, and a plot of pile head displacement versus time from testing of Pile 43, which illustrates how displacement rates decrease to essentially zero near the allowable load and continue to “creep” at the ultimate testing loads.

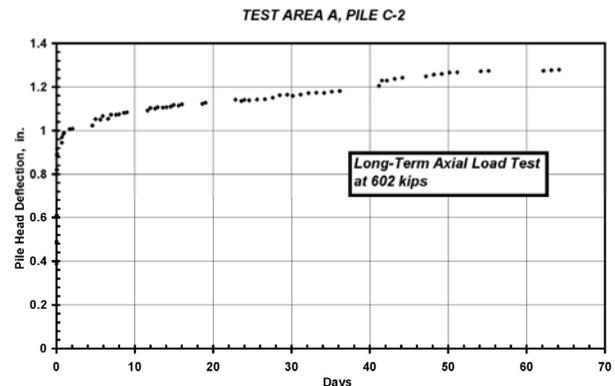
Figure 9. Results of long-term testing.

In general, the existing body of technical literature lacks actual instrumentation data of long-term settlement of pile foundations and in particular for APGD piles. In addition, the standard ASTM 1143-81 explicitly states that the results of short-term static tests are not necessarily applicable to long term performance. Measurements taken during the load-up cycle at the design load generally indicated that vertical movement ceased within 2 hours. It therefore was decided that performing the long-term test at the design load would not produce interesting or useful geotechnical results, so the ultimate load was chosen for the test. Long-term pile load testing was performed in Test Area A for a period of 64 days. The results, as shown in Figure 9, indicate nearly continuous pile settlement under the ultimate load (602 kip).

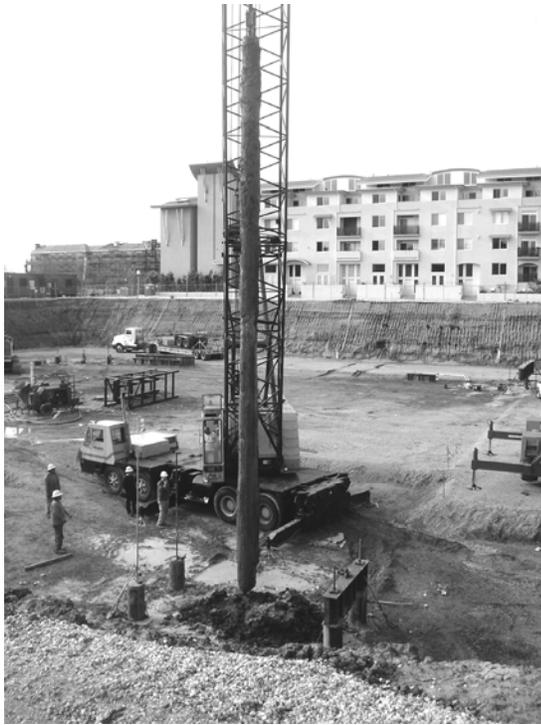
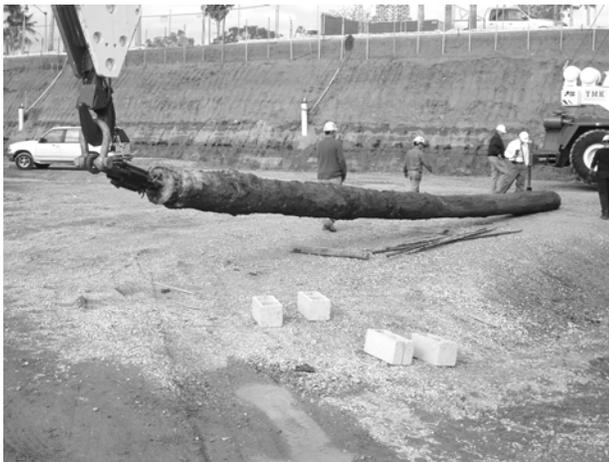
Figure 10. Exhuming (a) of Pile 45 from Test Area B, and (b) placing on ground.

Exhumation in Test Area B consisted of first utilizing the load test frame to jack the pile out as far as the frame would allow, followed by using a crane to hoist the pile from the ground (the jacking load reached a resultant load of roughly 200 kip). Figure 10 shows pictures of Pile 45 being exhumed.

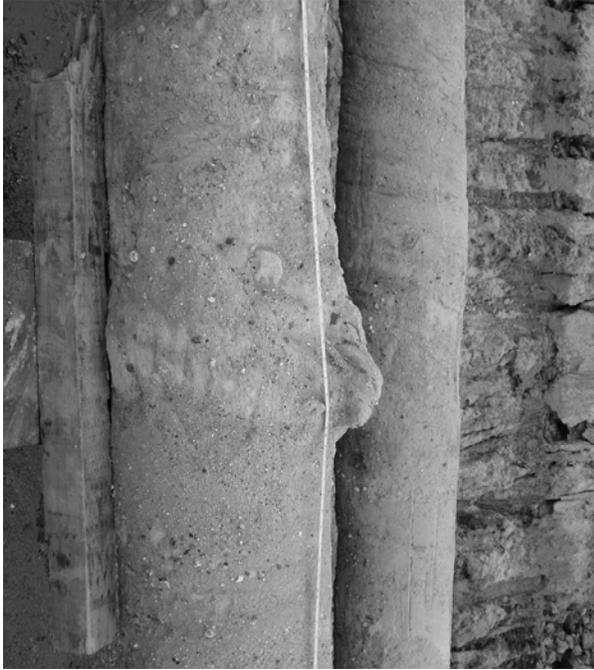
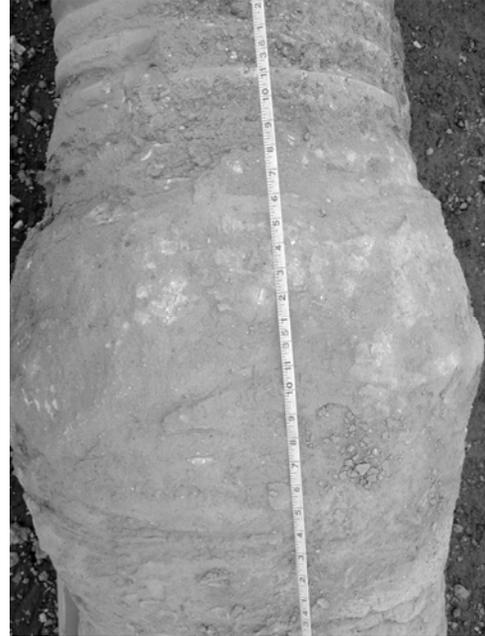
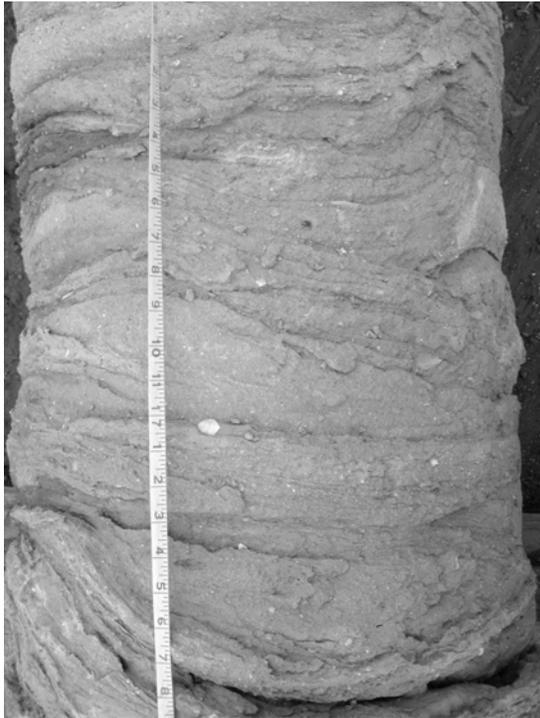
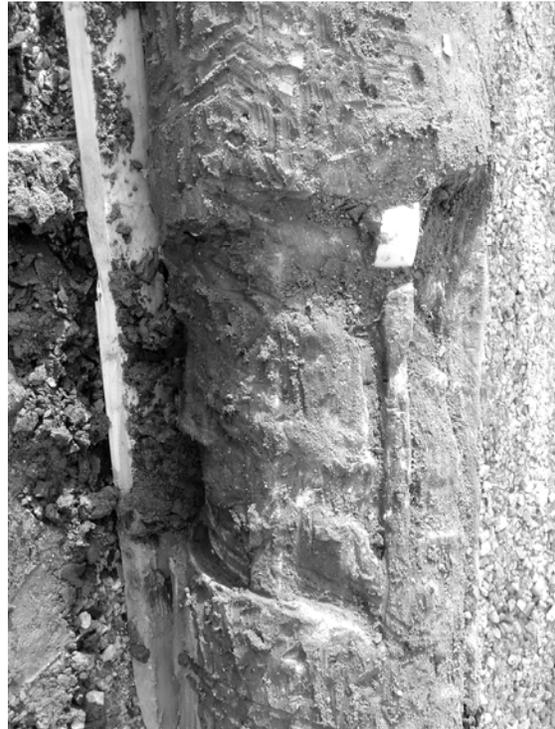
(a) Pile 'Wart'

(b) Pile 'Belly' – soft soil response

(c) Pile 'Swirl' - Probable Sensitive Soil response

(d) 'Necking' in Pile 45

Figure 11. Notable features found on some exhumed APGD piles.

Several interesting attributes or features of APGD piles, shown in Figure 11, were discovered once the piles were cleaned. Pile C-1 from Test Area A featured a “belly” shape at 35 feet depth where the pressurized grout expanded out into the soft clay formation, and a “swirl” at 17 feet depth possibly a

result of interaction among the high-pressure grout, displacement auger and sensitive clay formation.

Pile 42 from Test Area B showed a wart shaped nodule at 32 feet depth, which is likely high-pressure grout forcing out into the formation. Pile 45 had a narrow section at 23 feet depth, which is described as a “neck” feature. The “neck” in question corresponded to the same section of pile where the measured grout volume was less than 100% of that required to form a 16-inch-diameter pile. Figure 12 shows a plot of measured pile diameter and average pile diameter for Piles 42 and 45. Figure 13 is a photo of Pile 42 showing gravel from Layer 5 embedded into the pile. Figure 14 is a composite photo showing the entire length of Pile 42 after cleaning.

- Grout volume increments should be as small as practical to minimize potential of developing “necking” due to rapid withdrawal of the displacement auger. The “necking” feature that formed in Pile 45 occurred when a 5-foot grouting increment was used. Later inspection of the installation data showed that 2-foot increments would have indicated to the operator during production that not enough grout was pumped into that section of the pile.

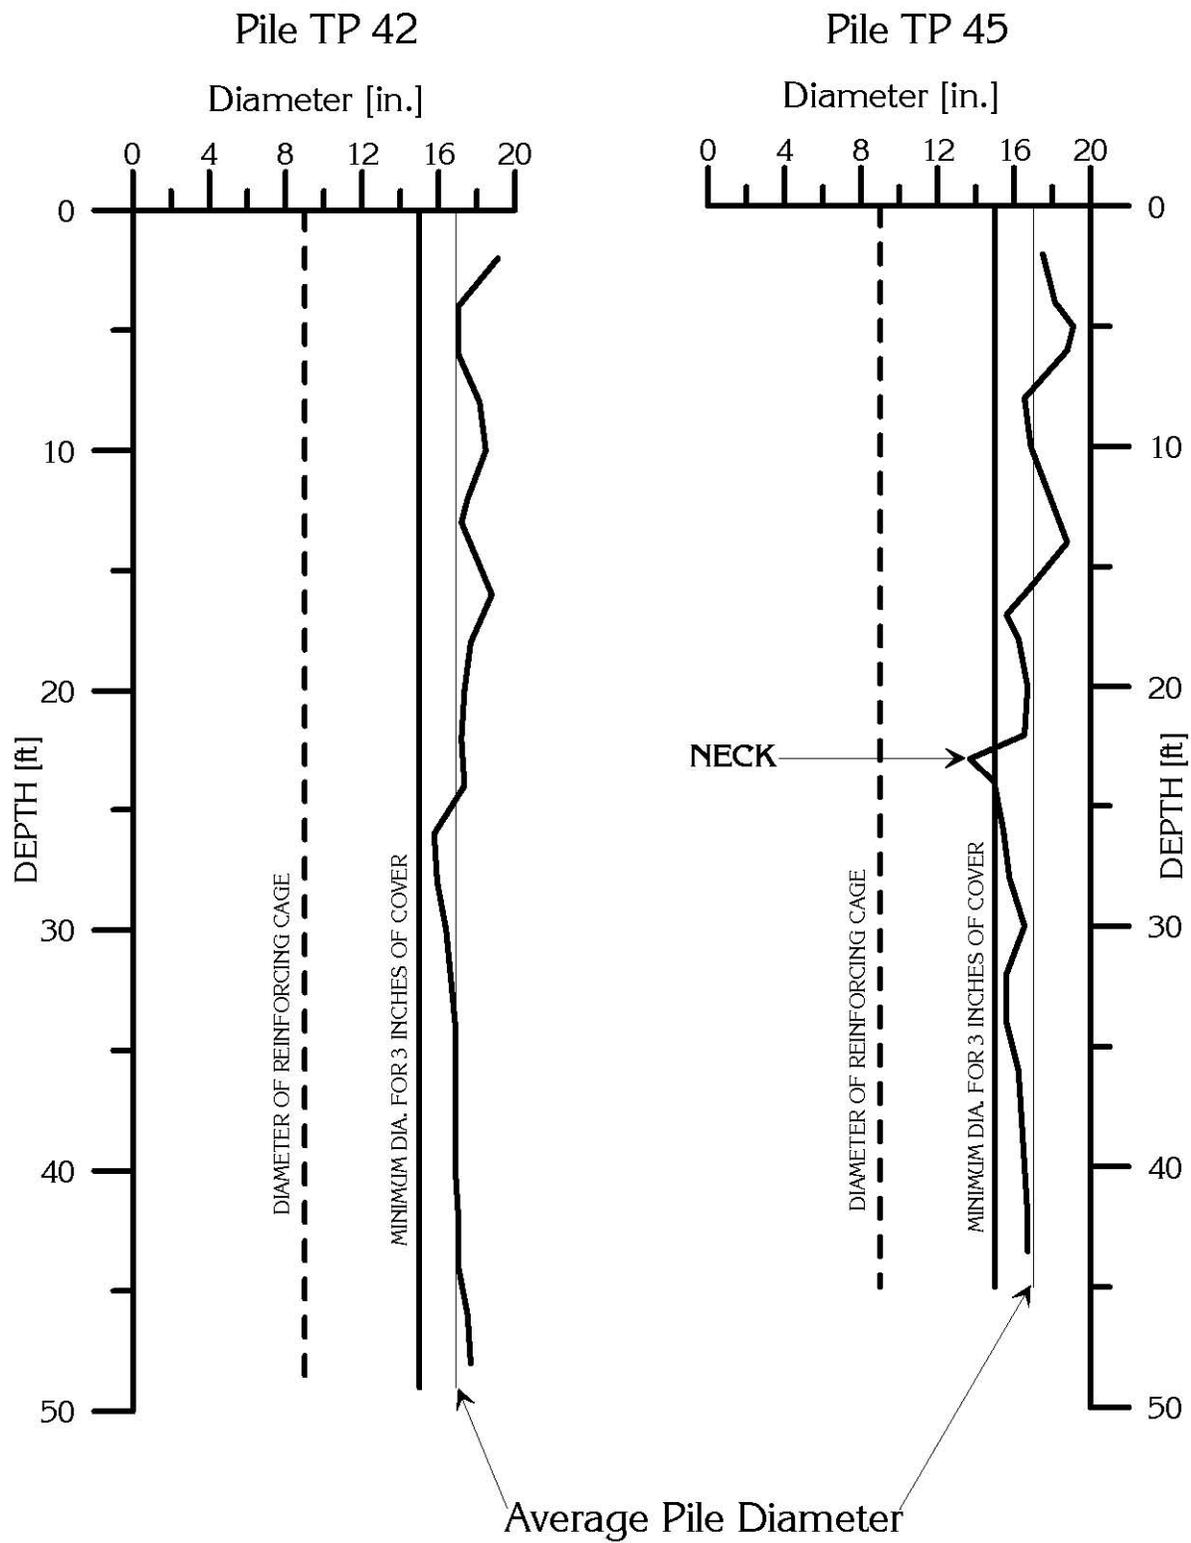
Figure 12. Comparison of average pile diameter based on total grout volume and measured diameter of exhumed Piles 42 and 45.

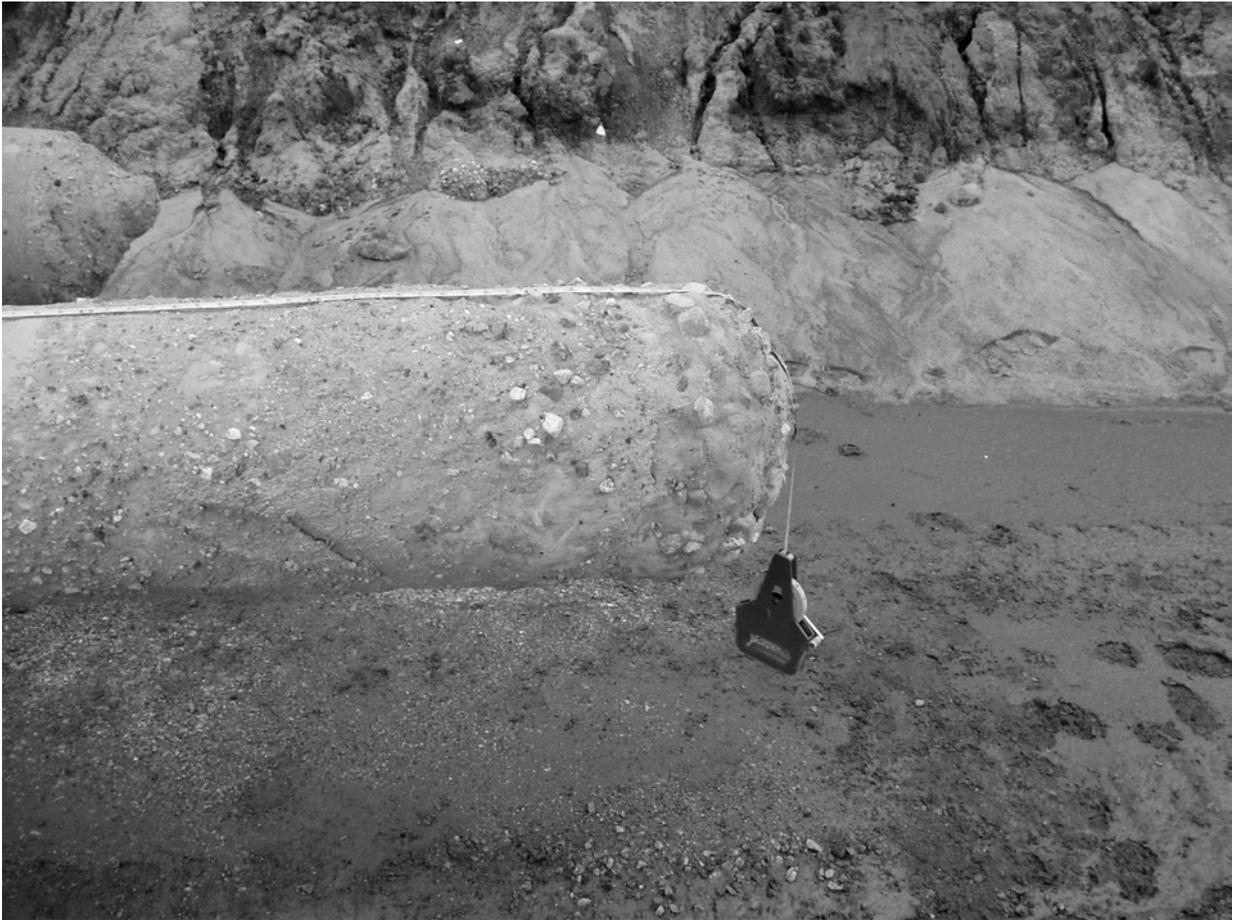
Figure 13. Tip of Pile 42 showing gravel from Layer 5 embedded into the pile.
