## GROUND IMPROVEMENT BY STONE COLUMNS AND SURCHARGE AT A TANK SITE

The ground improvement performed at the site of two 190-ft (57.9 m) diameter, 40-ft (12.2 m) high, 8 million-gallon (30,300 m<sup>3</sup>), circular steel water storage tanks consisted of installation of stone columns to mitigate liquefaction and lateral spreading potential and a surcharge program to reduce post-construction settlements. Settlement during the surcharge program ranged between 9 and 15 in. (225 and 375 mm) and post-construction settlement during the hydrotest was about 1.2 inches (305 mm).

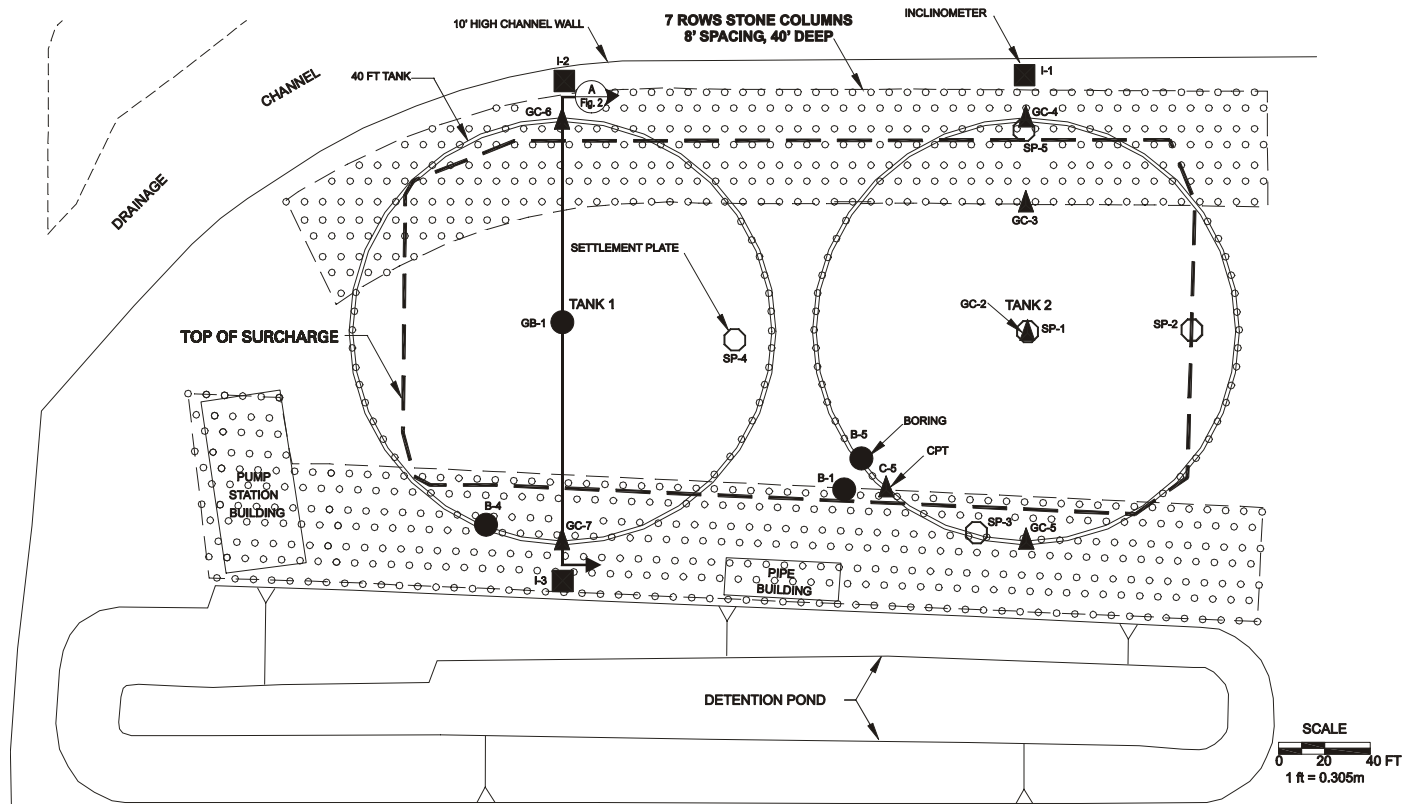
Fig. 1. Site Layout

- The lot is roughly rectangular in shape, measuring about 560 ft (171 m) in the east-west direction and 330 ft (101 m) in the north-south direction. Site layout is shown in Fig. 1. The tank site has grades ranging between El. 33 to El. 35 feet (10.1 to 10.7 m).
- A new detention pond with a depth ranging from 6 to 10 ft (1.83 to 3 m) and 3:1 (horizontal to vertical) side slopes was planned to be constructed about 25 ft (7.6 m) south of the reservoirs.
- The site is bounded on the north, and along the northwest corner, by a 10-ft (3-m) deep concrete-lined drainage channel with vertical side retaining walls.

The vertical 10-ft (3-m) high wall of the drainage channel is located about 25 ft (7.6 m) north of the two reservoirs (Fig. 1). Tank foundations were proposed at roughly 10 ft (3 m) above channel invert elevation. In addition, a detention pond was proposed about 25 ft (7.6 m) south of the two reservoirs. The detention pond was proposed with 3:1 (horizontal to vertical) side slopes and the bottom of the pond was up to 10-ft (3m) below the tank foundations. The presence of these low-lying areas results in reduced lateral stability compared to tanks on level ground. Results of stability analyses performed by PCSTABL/5M are shown in Fig. 3. For seismic stability, we used a pseudo-static coefficient of 0.15, and we reduced the shear strength of the soft to firm clay to 80% of the static shear strength. The calculated factors of safety for static and seismic conditions are 1.3 and 0.9, respectively, and are lower than the normally used values of 1.5 and 1.1, respectively. Since the calculated factor of safety for pseudo-static analysis was less than 1.1, we estimated that potential for large lateral movements using simplified Newmark-type analysis (Blake et al., 2002) was present during the design earthquake.

Three inclinometers were established along the north and south sides of the tanks near the channel and detention pond to measure lateral movements due to stone column installation and surcharge. Four survey points were set on the top of the channel wall to monitor both settlement and lateral movement of the channel wall. Five settlement plates, SP-1 through SP-5, were installed before placement of the surcharge to monitor settlement. The locations of these instruments are shown in Fig. 1.

- Inclonometers were installed at the locations shown in Fig. 1.
- Stone columns were installed along the northern and southern tank boundaries, adjacent to the drainage channel and detention pond. To minimize lateral movement and damage to the channel wall, the closest stone columns were kept at a minimum distance of 12 ft (4 m) from the wall. A total of 908 stone columns were installed in 54 days.

- Installed settlement plates SP-1 through SP-5.
- After completion of the stone columns, import fill was placed to preload the site to the boundaries shown in Fig. 1. The placement of about 80,000 cubic yards (61,210 cubic meters) of fill was completed from April 16, 2001 through May 30, 2001 a period of about 45 days.
