GROUND IMPROVEMENT BY STONE COLUMNS AND SURCHARGE AT A TANK SITE

Kul Bhushan

ABSTRACT

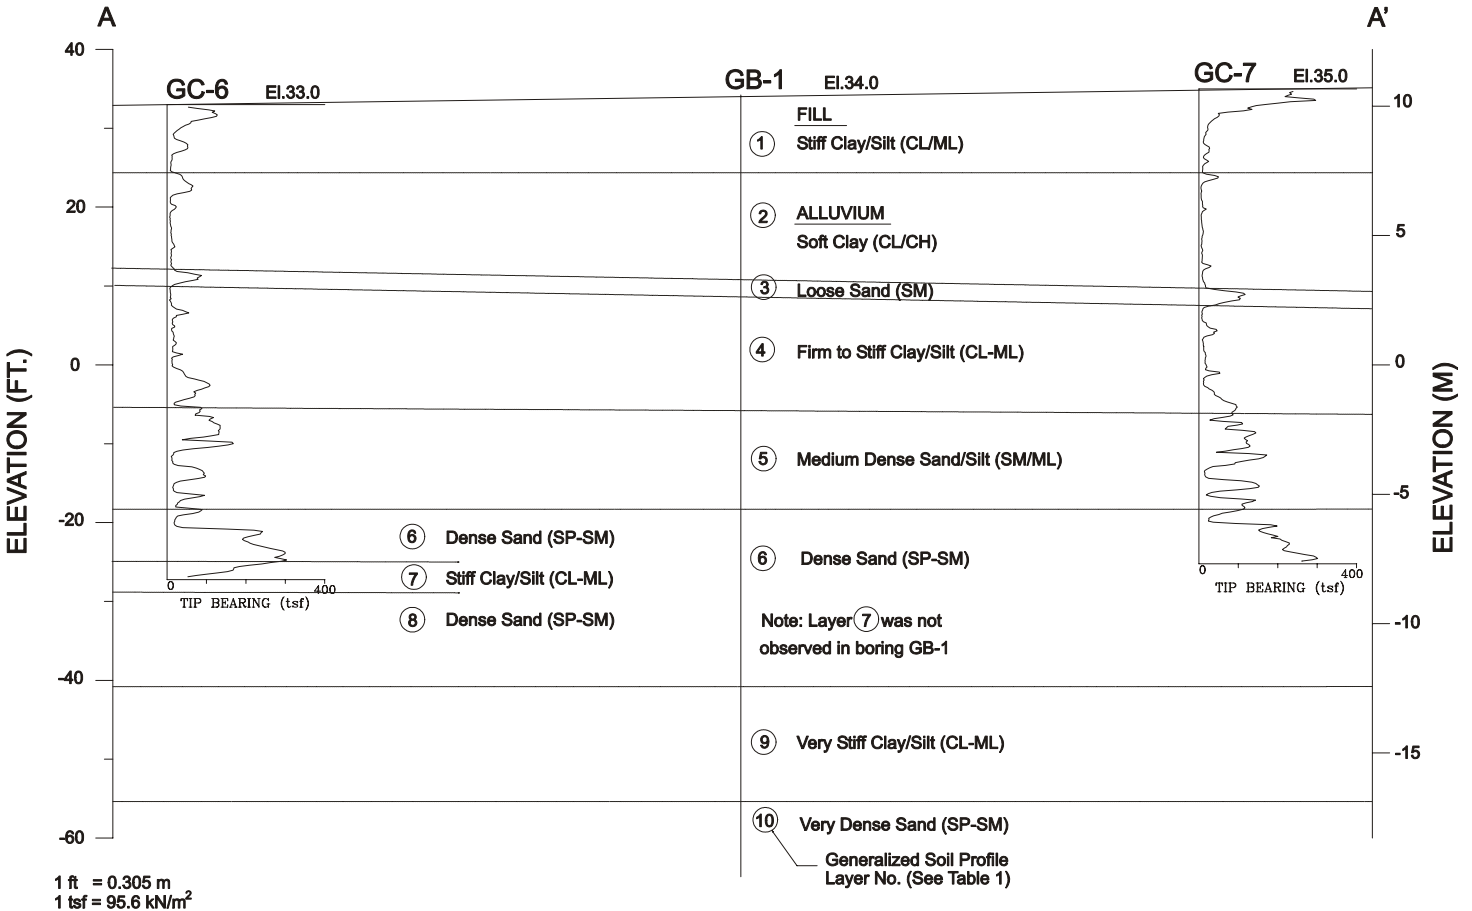
Fig. 2. Generalized Soil Profile

Based on data from the borings and CPTs, the soil profile is relatively uniform. Beneath a cap of stiff clay/silt man-made fill soils, deep alluvial sediments underlie the site. Above El. -18 ft (5.5 m), the alluvial sediments consist primarily of compressible soft to stiff clay/ silt layers, with isolated zones of loose to medium dense sands. Below El. -18 ft (5.5 m), the sediments consist of dense to very dense sands and stiff clays. We developed a generalized soil profile including strength and compressibility parameters shown in Table 1. A generalized cross-section illustrating the soil profile is shown in Fig. 2. The groundwater was present at depths ranging from 10 to 16 ft (3 to 4.9 m) below existing grades.
